# CURRENT CONDITION OF IRRIGATION SYSTEMS IN SELECTED TERRITORY

*Abstract:* This paper aims to map the state of the irrigation system in the selected area and the evaluation of its components. The area of interest is located near the Malonínský brook near the town Jevíčko. As part of the elaboration of the work methodology historical material has been obtained from the flow manager and the local government, which has been preserved to the present day. In addition, the area of interest was visited (in October 2016, March and August 2017), reconnaissance of the terrain and photo documentation of the current state of the constructions were realized. The collected information was processed and evaluated. In the area of interest there are 6 categories of constructions of surface watering system Malá Haná, which was built in the 1930s. This system is currently largely non-functional outside Smolenská Water Reservoir, which is maintained in a conditional state, and as the only one of the original irrigation system can be used for other functions or possibly incorporated in the future into a new irrigation system based on modern austerity technologies.

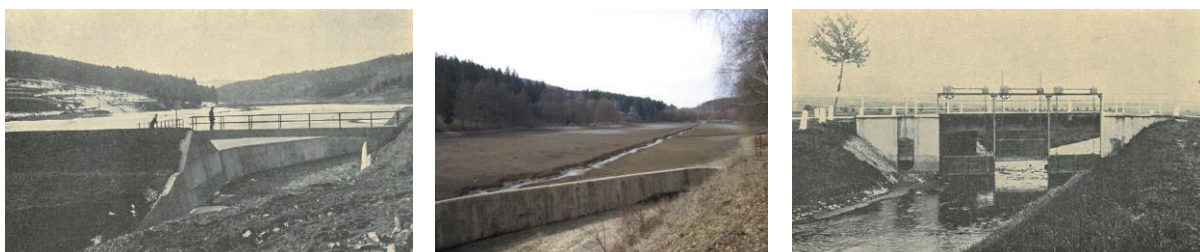
The Smolenská water reservoir is the main landscape-forming element in the area of interest and served as a source of water for the irrigation system in a period with a lower flow of water in the Malonínský Creek. Smolenská water reservoir in year 1933 is shown in Figure 2 on the left.

Figure 2 Smolenská water reservoir in year 1933 (on the left), Smolenská water reservoir in year 2017 (in the middle), A bridge with a floodgate at Jevíčka stream in 1933 (on the right)

At present, the reservoir is supplemented by a sedimentary pretension, which was established by the State Ameliorative Administration for the detention of the floodplains before entering the Smolenská reservoir. Together with the pretence, a pool was built at the inflow to the reservoir to increase the biodiversity of the area and support amphibians. In 2009, the Agricultural Water Management Administration completed the reconstruction of the security spillway and the discharge facility. At present, the Smolenská reservoir and the preserve are discharged due to the filling of the preload and the subsequent flow of the spills directly into the reservoir. A project to unload the reservoir and to reconstruct the discharge objects is being prepared. The current reservoir manager of adjacent streams is the Povodí Moravy s.p. Smolenská water reservoir in year 2017 is shown in Figure 2 in the middle.

Smolenská reservoir is currently the most conserved part of the original irrigation system. After measures to prevent settling of the sediment in the reservoir and its removal, the capacity of the reservoir will increase and therefore this higher capacity can be used for the supply of any newly built irrigation system or it will be used as a capacity to capture and transform the flood flows on the Malonínský Creek.

drifts when the flow was blocked. The floodgate weir on the road bridge of the Jevíčko-Biskupice road had three fields with a height of shutters of 1.1 m. The sluice in the area over the highway had two fields with the lightness of 4.2 m and shutters 1.4 m high. Floodgate on the bridge in Smolenská had two fields with a shutters height of 1.48 m (Pernica 1997). A bridge with a floodgate at Jevíčka stream in 1933 is shown in Figure 2 on the right.

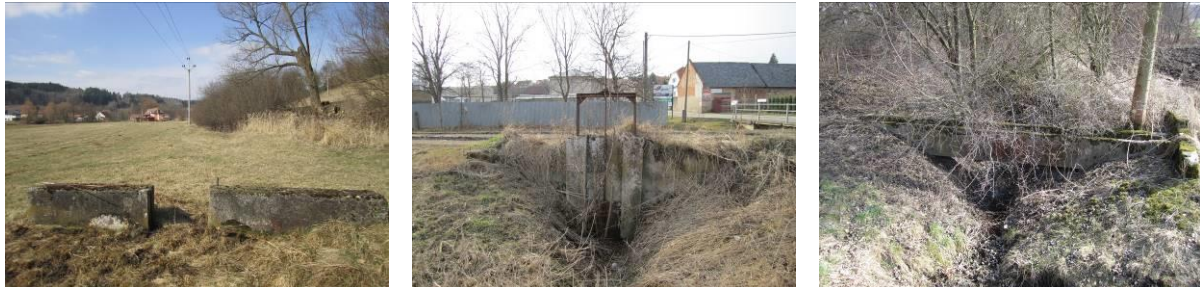
The setting devices served in their full engagement to retain and drain the water in the pots and to create a drop of water across the meadows. The setting devices were made of concrete with a hole for a wooden stopper. The area around the bucket was tiled with tiles. The length of the overflow edges from the drive was 40–80 m. At present, the trays on the meadows above Smolenská Reservoir and in the area above the highway are preserved. At present, these objects are unjustified because the drives on which they were located no longer exist. Setting device at none exist drive in 2017 is shown in Figure 4 on the left.

Drains were an important part of localities where watercourses were lined with a low hill. So, the water could drain away. Nowadays the drainage is located in the embankments around Jevíčko, they are in a reserved position and do not fulfil their function. They cannot even perform a flood-proof function because the adjacent decks are no longer properly shaped and damaged in several places. They are more or less technically interesting object in the landscape. Example of drain in 2017 is shown in Figure 4 in the middle.

In the area of interest there is the last aqueduct in the area above the highway. This aqueduct served to transfer the drift stream over the waterline at another height level. Currently it does not fulfil its function and its use is not offered. The aqueduct in Jevíčko was removed. An aqueduct across nameless watercourse in 2017 is shown in Figure 4 on the right.

*Figure 4 A setting device at none exist drive in 2017 (on the left), Example of a drain in 2017 (in the middle), An aqueduct across nameless watercourse in 2017 (on the right)*

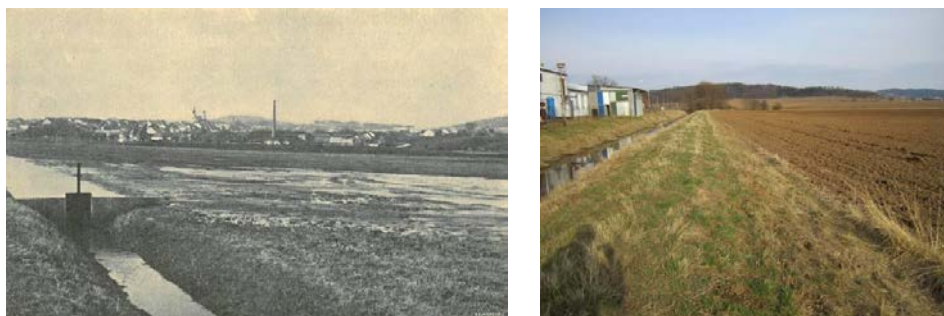
Drives were connected to a flooded property and brought water from streams to irrigated meadows. The drives have a trapezoidal shape with a sloping slope of 1:2 in cross-section to ensure easy maintenance. In the area of Malá Haná, the flood irrigation did not work well and surface watering was the main type of irrigation. The water flowing from the meadows was drained through the wastewaters back into the watercourse. Wastewater also served as drainage at higher blurring of the meadows. Care was taken to ensure that the meadows were not unnecessarily dry. An irrigation millrace with a floodgate in 1933 is shown in Figure 5 on the left.

Drives are mostly covered today. In the area of interest, part of one of them is located in the area below the Smolenská reservoir and in the area above the high. The drive, which enters the area of interest on the southern edge of Jevíčko, is currently part of drainage from the 70s of the 20th century.

Due to the predominant filling of the drives it is not possible to use them. Drills that have not been covered are currently part of a drainage whose functionality needs to be verified.

*Figure 5 An irrigation millrace with a floodgate in 1933 (on the left), Damming along the Malonínský brook near Jevíčko in 2017 (on the right)*

Nowadays, the fence along the Malonínský brook is located close to its confluence with Jevíčka. At present, fencing is counterproductive, because in the case of smaller floods, the water cannot be poured out of the water into the surrounding fields. Damming along the Malonínský brook near Jevíčko in 2017 is shown in Figure 5 on the right.

However, with a higher flood flow, flood overflows may occur and the property is at risk. The drainage and permeable objects of the irrigation system in the dykes are already dilapidated and inoperative. Consequently, the remainder of the irrigation system cannot be considered as an effective flood protection measure.
